Long-term dynamic monitoring and CFRP post-tensioning for a major bridge restoration

City of Wichita Implements Pioneering Rehab Technologies

by Karl J. Svaty, Jr., Monica Lane, Nabil F. Grace, and Jay Thomas

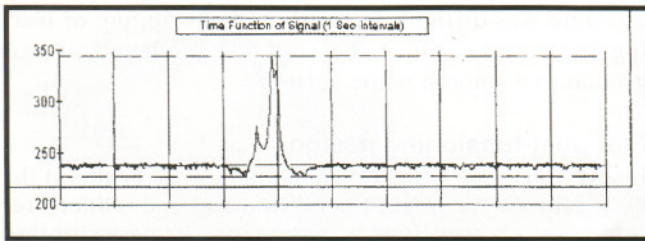
The structure demonstrated an excellent distribution of loading, including responses obtained when vehicles exceeded the posted 10-ton loading restriction. The load transducers were initially calibrated using known vehicle weights, and the maximum loads were continuously recorded. Figure 1 shows the recorded response of a 35-ton concrete transit mix truck that crossed the bridge. The time function of the strain shows the distribution of the load over the span as the truck crossed and its return to normal after the truck passed.

Fig. 1 — Recorded signal from heavily loaded 3-axle concrete mixer. Maximum load = 346 microstrain; minimum load = 229 microstrain; difference = 117 microstrain.

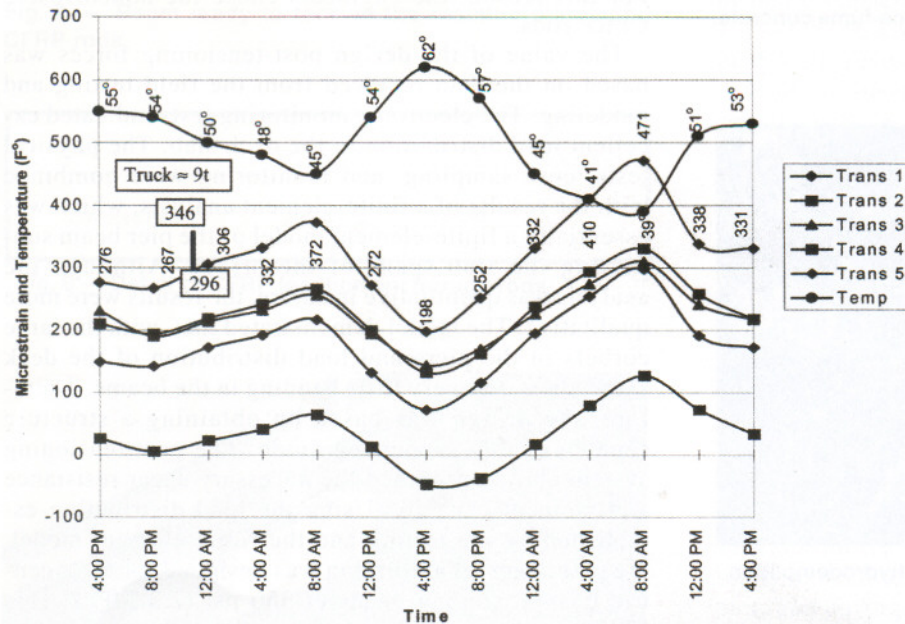
Fig. 2 — Microstrain variations due to thermal response over 48 h — Dec. 9 to 11, 1997.

indicated that the structural components were still in excellent load-carrying condition. Figure 2 shows the thermal response of five spans over a 48-h period. On Transducer Number 5 (Trans 5), the microstrain ranged from 198 to 471 when the temperature at the on-board computer changed from 62 to 39 F (17 to 4 C). The upward direction of the curve indicated that the structure soffit was moving into tension as the temperature cooled. As the temperature warmed, the curve turned downward, indicating that the bridge soffit was going into compress-

sion. The wide range of movement was attributed not only to the condition of the structure, but also to the black asphalt deck, which was highly responsive to direct sunlight warming and evening cooling.

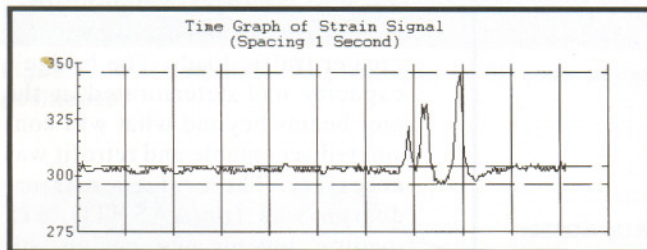
Fig. 3 — Microstrain on Transducer 5. 5-axle vehicle, 9 tons. Maximum = 346 microstrain; minimum = 296 microstrain; difference = 50 microstrain.

In Fig. 2, a 9-ton truck is represented by a vertical line, showing the maximum and minimum microstrains recorded in the signal graph in Fig. 3. The difference in the vehicle's microstrain is 50. The maximum microstrain difference in the transducer response due to thermal reaction is 273. The overloaded truck in Fig. 1 produced a microstrain of 117. Therefore, even vehicles exceeding the legal load limit were not affecting the structure as much as the thermal response. The engineers postulated that by removing the asphalt deck and replacing it with silica-fume concrete (Fig. 4), the movement of the structure due to thermal response would be greatly reduced.

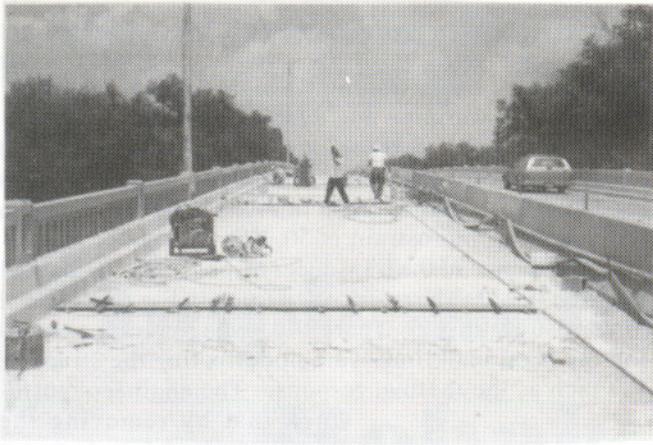
Fig. 4 — Asphalt deck replaced by white silica-fume concrete. Note the bridge is still open to traffic.

now uses this type of concrete almost exclusively. Silica-fume concrete is very impermeable and much stronger than conventional concrete, which justifies the increased expense of the material. One disadvantage, however, is that it is more susceptible to heat shrinkage. Another is that the concrete can be difficult to work with. On this project, a superplasticizer had to be added to the mixture to provide a workability time of about 45 min. The

concrete was difficult to finish without ripping or tearing the surface. Once the concrete hardened, it was ground to a smooth white surface.

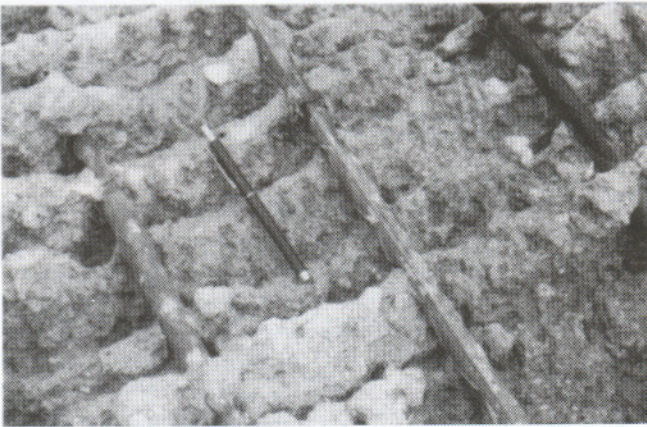
Removal of the unsound deck concrete was carried out by hydrodemolition because this method would not harm the sound concrete. It also helped to avoid concussion loads to the concrete deck associated with demolition by pneumatic tools. The quality of the old concrete ranged from excellent to extremely poor, most likely due to suspect quality control and a lack of available admixtures in 1937. During the demolition, some areas lost only 1/2 in. (13 mm) of concrete thickness while other areas lost up to 5 in. (130 mm). Existing reinforcement was found to be in good to excellent condition. In many places, the original wire ties were still intact (Fig. 5).

Fig. 5 — Existing reinforcement exposed by hydrodemolition.

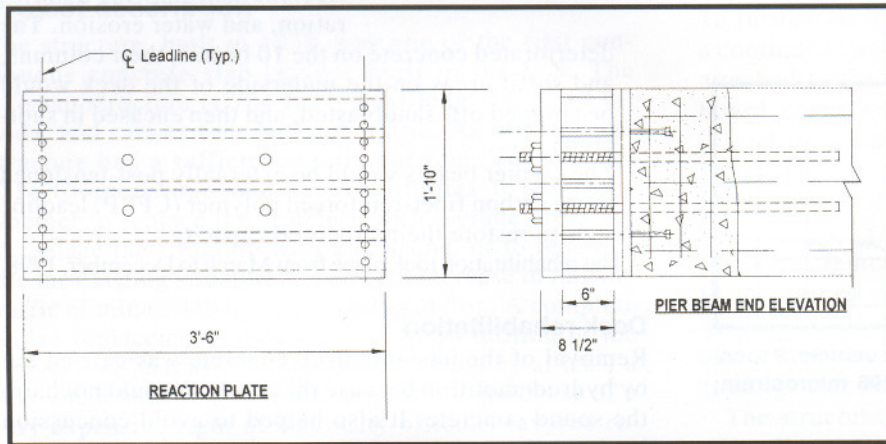
Fig. 6 — Elevation details of reaction plates and bearing plates.

Each pier beam had 20 such rods, 10 on each side, affixed to it. Reaction and bearing plates (Fig. 6) held the rods in place and compressed the pier beams to their design capacity. The reaction plates were of galvanized steel and weighed 800 lb (360 kg) each. The bearing plates were of galvanized steel and had bearing bars welded to them. Each end of the pier beam was chipped off using light chipping hammers to obtain adequate bearing on the existing concrete for the bearing plates, which were then cast in place (Fig. 7).

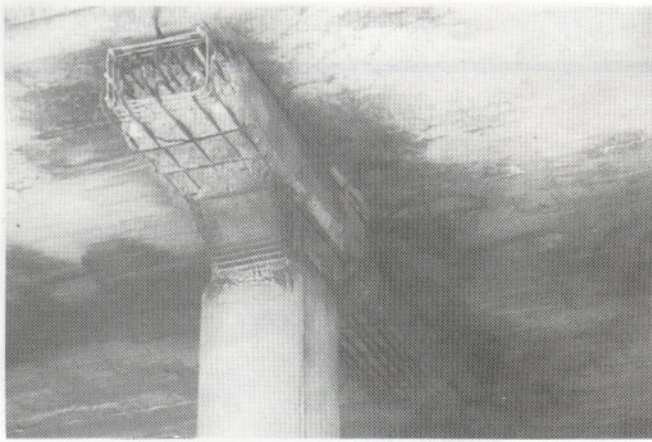
Inspection of the piers revealed that the 10 beams at the deck joints were in poor condition and had reduced reinforcing section due to corrosion. They exhibited spalling and corrosion from years of continual water and chloride exposure. The 26 intermediate pier beams were in relatively good condition. The locations of deck joints created the potential for future deterioration, so post-tensioning systems with conventional high-strength strands or bars would be susceptible to stress corrosion. For this reason, the engineers chose the noncorrosive CFRP rods.

Fig. 7 — Beam ready to receive the reaction plates and CFRP rods.

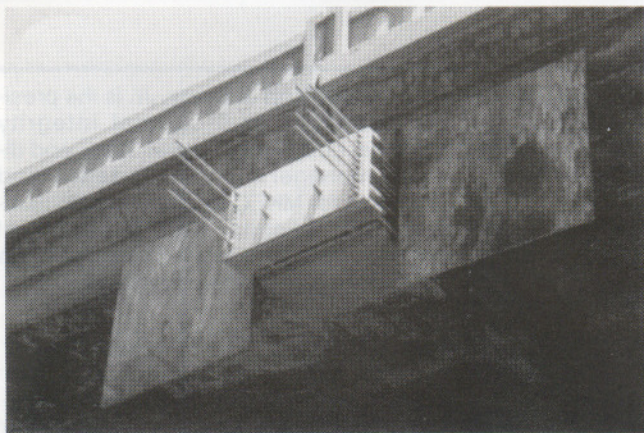
Fig. 9 — Reaction plates in place and CFRP rods being positioned.

Placing the CFRP leadline rods required extreme care so that they did not twist at any time during the installation or tensioning procedure (Fig. 9). Twisting could cause loosening in the anchorage and torsion in the rod. The possibility of a small angle of twist in the rod was likely to occur during assembly of the anchor head, coupler, and during post-tensioning. This twist would have significant adverse effects on the breaking force of the post-tensioning rods.

After the CFRP rods were placed, they were each tensioned to 12,500 lb (56 kN). During the construction, a rod failure occurred below the specified tension due to twisting, and corrective field procedures eliminated this problem by utilizing the jack only for tensioning. This would ensure that only a linear force was applied. Seven days after the tensioning, the rods were examined and tested. The tests showed an average loss of 125 lb (556 N), which was not considered significant. The loss probably had some creep involved, but the majority of the loss was elastic shortening.

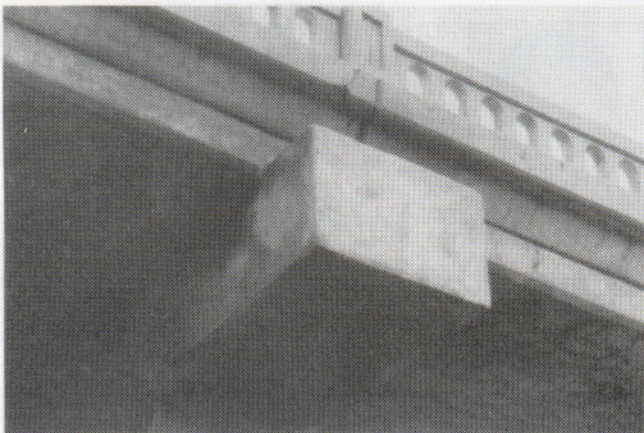
Fig. 10 — Completed pier after encasing all elements in shotcrete.

repair areas were shotcreted to build up the required cross section. Shotcrete was chosen because it did not require the use of forms and had a high strength. The pier beams and their columns were completely encased in a 4 in. (100 mm) layer of shotcrete to strengthen and protect them from further deterioration. The samples of old concrete were tested to 3500 psi (24 MPa), and after the shotcrete application the samples tested to 6000 psi (41 MPa).

Even though the CFRP rods are inert to most common contaminants, they were still encased in shotcrete (Fig. 10) to prevent debris and other objects from being directed at them. Testing was conducted to determine whether the shotcrete would adversely affect the post-tensioning properties of the CFRP leadline rods; the results suggested it did not. The only apparent change was the dull to shiny finish of the rods when the test was completed. The reaction plates were also encased to protect them from weather, salts, and other deicing substances.
