Flexural and Shear Strengthening of Concrete Beams Using New Triaxially Braided Ductile Fabric

by Nabil F. Grace, Wael F. Ragheb, and George Abdel-Sayed

ACI Structural Journal, V. 100, No. 6, November-December 2003.

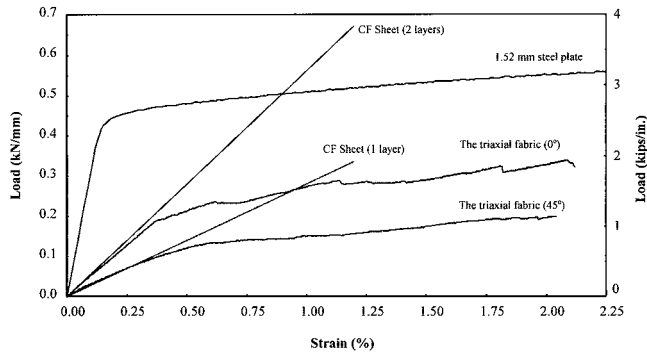
Fig. 4—Tensile properties of materials used.

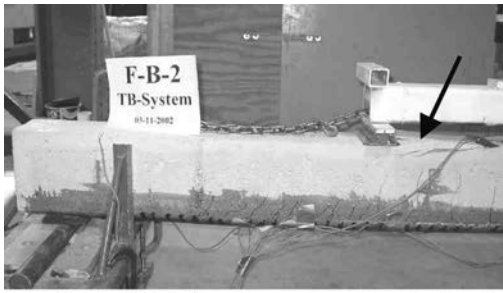
(a) Beam F-B-2 (concrete compression failure)

failed less catastrophically than Beam F-CB-1. Beam F-B-2 yielded due to the yielding of both the steel reinforcement and the fabric, while beam F-CB-1 yielded due to the yielding of the steel only. The carbon fiber sheet had a midspan strain of 0.7%, which indicates that it reached 58% of its load capacity when it failed. In contrast, the triaxial fabric had a midspan strain of 1.06% at beam failure, which was more than the strain necessary to reach most of its load capacity (more than its yield-equivalent strain). Figure 8(a) and (b) show photos of the two beams after failure.

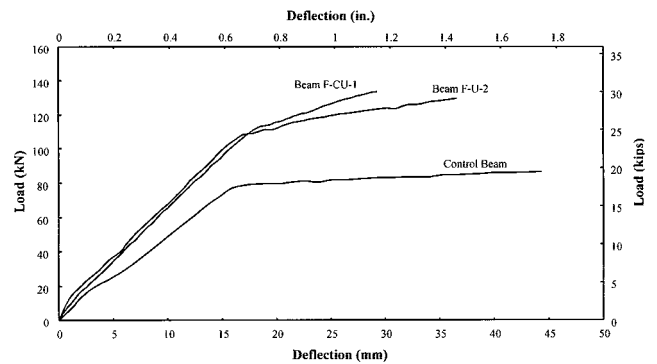
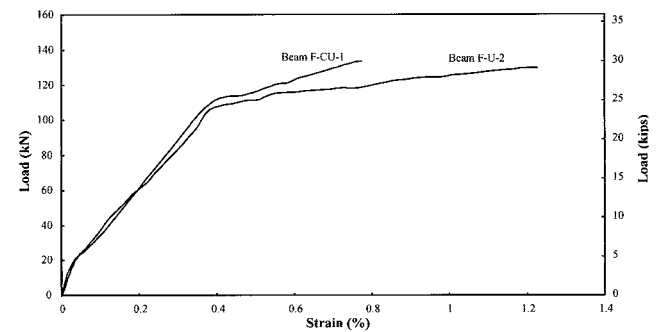
(a) Midspan deflection

(b) Midspan FRP strain

Fig. 10—Behavior of Group A beams with U-wrap scheme.

Beams F-U-1, F-U-2, and F-CU-1—Beams F-U-1 and F-U-2 were strengthened with one layer of the triaxial fabric as a U-wrap along the bottom face, which extended 152 mm (6 in.) on both sides. Beam F-CU-1 had the same U-wrap scheme but with two layers of the carbon fiber sheet. The results of Beams F-U-1 and F-U-2 were very similar and, hence, the discussion that follows is focused on Beam F-U-2 to avoid repetition. Test results from Beams F-U-2 and F-CU-1 are shown in Fig. 10. Both beams showed similar initial stiffnesses. Beam F-U-2

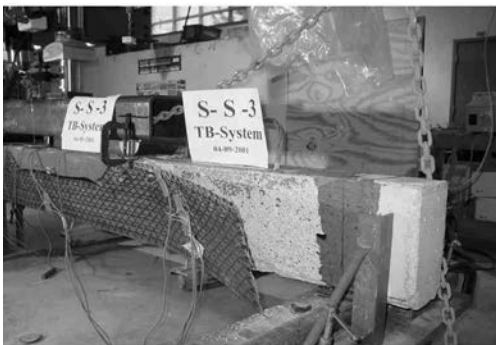
(c) **Failure of beam S-S-3**

Beam S-S-3—This beam was tested at a shear span of 736 mm (29 in.), slightly less than that of the other two beams. The beam had a similar strengthening scheme to that of Beams S-S-1 and S-S-2. To avoid damage of the concrete in the compression zone due to buckling of the fabric, as experienced by Beam S-S-2, however, a 76 mm (3 in.) wide strip at the top of the beam in the constant moment zone was not covered with the fabric. The beam failed by debonding of the fabric (Fig. 16(c)) at a shear force of 141 kN (31.7 kips). The fabric strain readings showed a strain of 0.45% when the beam failed.
